BELZONA REPAIRS ORE BRIDGE CRANE AT BLAST FURNACE

Steel Mill in Ohio, U.S.A.

1994

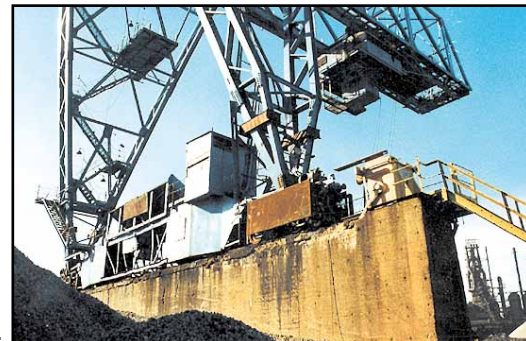
1. Overall view of Ore Bridge crane.
2. Template "C"- clamped in place.
3. Finished keyway with no machining required.
