BELZONA® 1391 PROTECTS BEET COSSETTE MINGLER

Sugar factory in the United Kingdom

1999

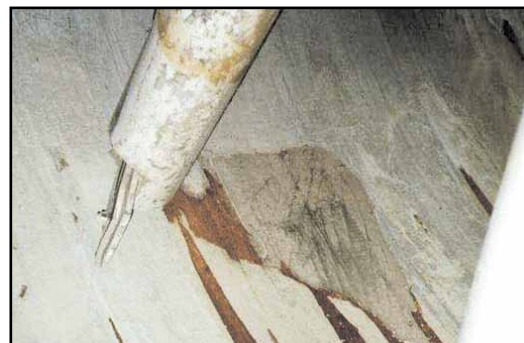
Excessive corrosion and eventual failure of the existing glass flake protection system.

1. General view of the application site.
2. Equipment prior to surface preparation.
3. Application completed with Belzona® 1391.
