BELZONA® 1391 PROTECTS JUICE HEATER END COVER

Sugar factory in Ireland

The end cover of a juice heater.

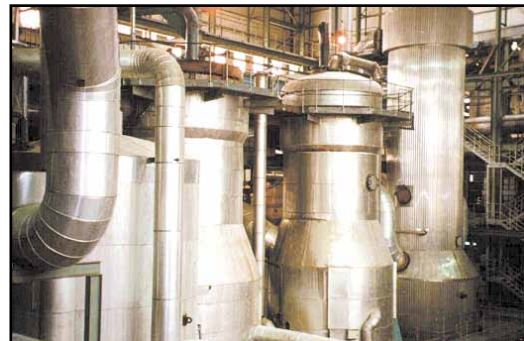
1. General view of the application site.
2. Equipment prior to surface preparation.
3. Application completed with Belzona® 1391.

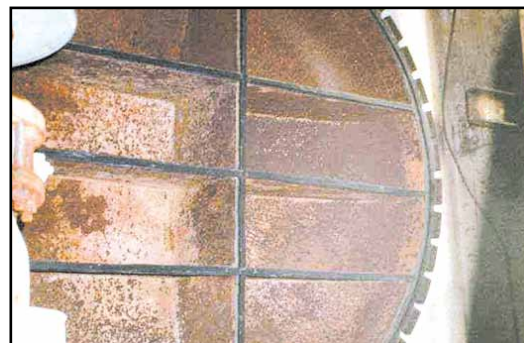
2.

Extensive corrosion pitting.
