## BELZONA REPAIRS SUCTION DRUM EXIT

Papermill in Quebec, Canada

Exit section of a paper suction drum.

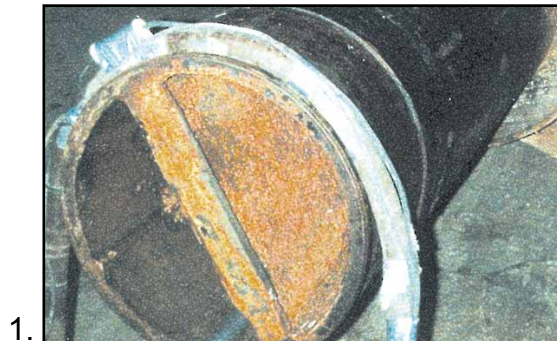
Severe corrosion produced by water and clay.

1. The equipment prior to repair.
2. The surface has been prepared.
3. Perforation repair using Belzona® 1311 and perforated metal sheet.
4. Equipment is ready to be put back into service.
