## BELZONA STOPS METHANE LEAK

Sewer plant in Alabama, U.S.A.

Cracks in top of methane tank

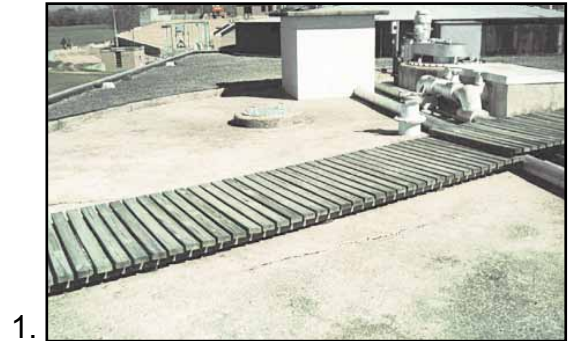
The 30-year-old tank had cracks and pin holes allowing methane gas to escape.

1. Top of tank with cracks and pin holes.
2. After cleaning tank, Belzona® 4111 was used to fill cracks.
3. First coat of Belzona® 5811 was applied.
4. Belzona® 5811 (black and beige) were mixed to a grey color and applied for the second coat.
