BELZONA REBUILDS SLUDGE PUMP COMPONENTS

Wastewater treatment plant - Vancouver, Canada

Rebuilding of sludge pump components.

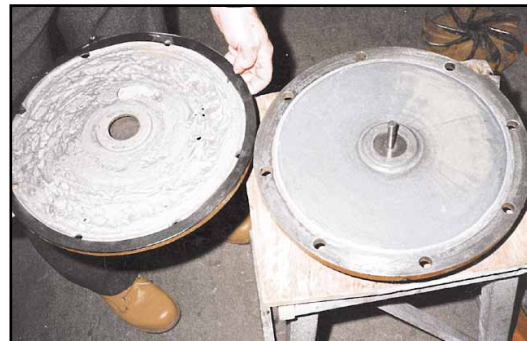
1. Backing plates - before and after the Belzona repair.
2. The new impeller was also protected.
3. The eroded casing.
4. The entire casing was rebuilt with Belzona® 1311, and protected with Belzona® 1321.
