## A BELZONA SOLUTION THAT HOLDS WATER

The University of Iowa, U.S.A.

A two-level fountain

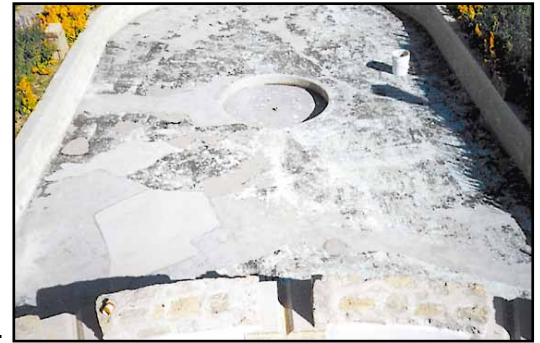
1. Overall view of the fountain.
2. Badly damaged concrete in the wall of the upper portion of the fountain.
3. Putting the finishing touches on the lower fountain area.
4. The fountain during 1999 - still trouble free.

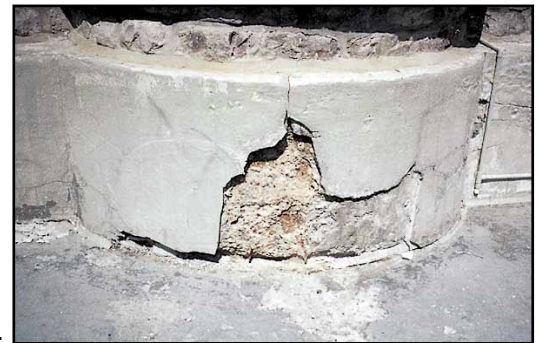
2.

The concrete and stone base was badly damaged with a large number of cracks and hollowed areas. Water was leaking into underground service tunnels. Previous repairs did not last for more than one year.

Belzona® 4141 (Magma Build)

Belzona® 3111 (Flexible Membrane)

Belzona® 4111 (Magma-Quartz)

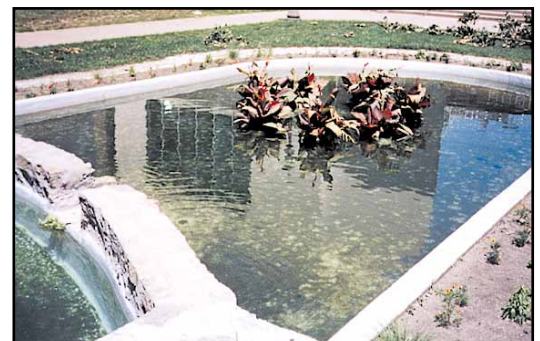
4.

Inspection of the fountain in late 1999 revealed that the Belzona repairs were performing as anticipated. The fountain was donated to the university by the class of 1936.
