BELZONA® 2000 SERIES ELASTOMERS FOR SWIMMING POOL EXPANSION JOINTS

Expansion joints on indoor swimming pool

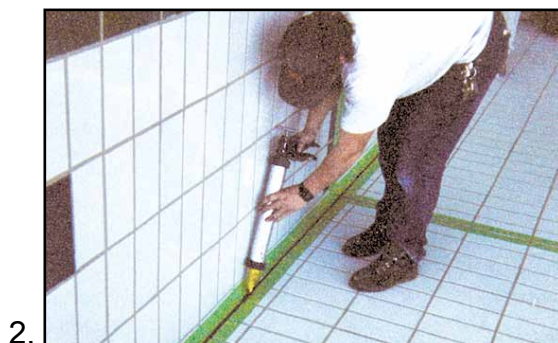
1. General view of the facility.
2. Injecting the Belzona® 2221 into the expansion joints.
3. View of the completed pool.

The application was carried out in accordance with a modified version of Belzona Know-How System Leaflet FPA-6.

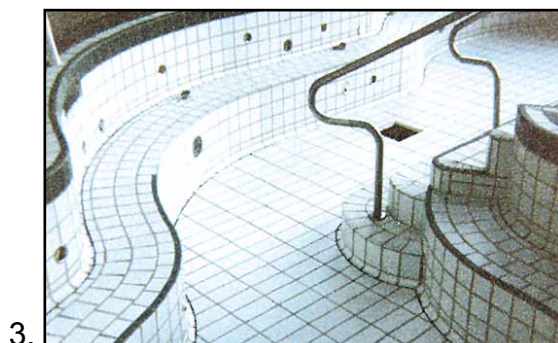
There has been no maintenance on these expansion joints since installation in 1996. This application has saved both maintenance time and money. There is no more loss of expensive, chemically treated water.
