## BELZONA REPAIRS WASTEWATER PUMP

Wastewater treatment facility - Vancouver, Canada.

Large six foot diameter centrifugal pumps.

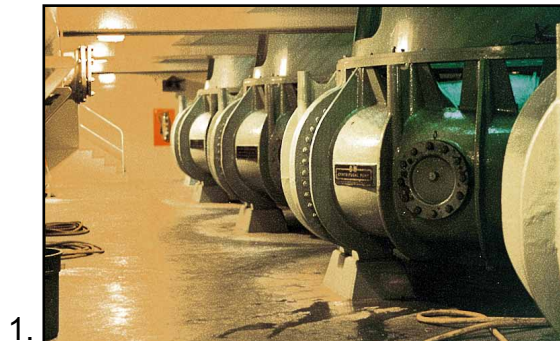
1. Large centrifugal pumps.
2. Pumps disassembled for repair.
3. Volute rebuilding in progress.
4. Rebuilding in progress.

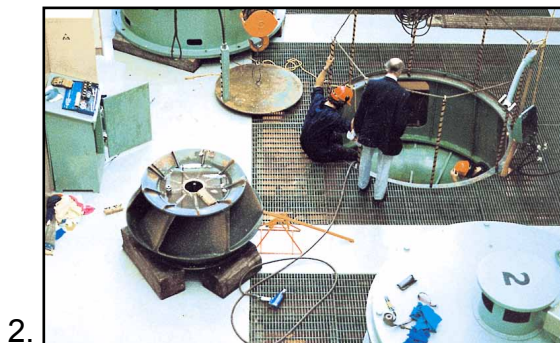
Pumps were suffering from severe erosion around the volute. It was difficult to remove the unit for repair due to its size and location.
