BELZONA PUTS A STOP TO WATER INGRESS IN PARKING GARAGE

Parking facility, Quebec, Canada

October 1997

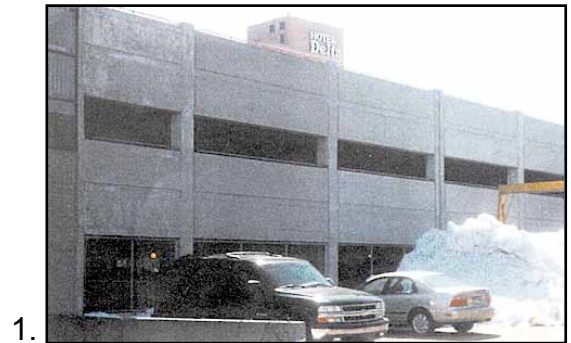
1. General view of the parking garage.
2. Joint cleaning and placement of foam backer rod.
3. Surface preparation.
4. Completed expansion joint at top level of the building.

The application was carried out in accordance with Belzona Know-How System Leaflet FPA-6.
