BELZONA SPECIFIED PROTECTION OF SOAP PLODDERS

International soap manufacturer - Malaysia

Silumin worms from soap plodders used in the manufacture of soap.

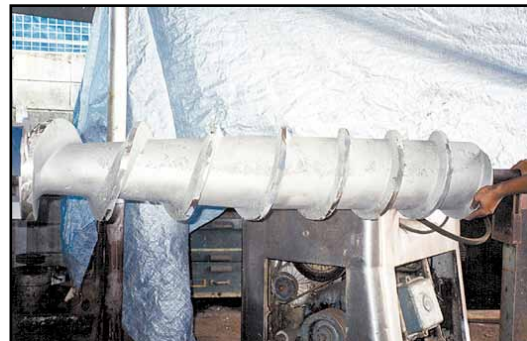
Wear and chemical attack of the worm's surface.

1. General view of plodder worm after cleaning.
2. Application underway.
3. Completed application.
