## BELZONA BRIDGES THE GAP

Wastewater treatment plant - United Kingdom

A new pipe work section required connecting to existing pipe work.

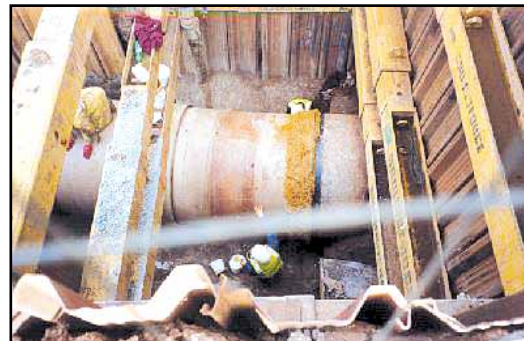
Having to connect new, industrial polypropylene pipe to the old iron pipe which is severely pitted, making it impossible to obtain a water tight seal for the joint sealing ring.

1. Overhead view of both old and new pipe before repair and connection
2. The sections of pipes that were to be connected.
3. Run the pipes with connecting collars, following Belzona repair.
4. Completed repair.
