BELZONA RESTORES ACID FLOW BY REFURBISHING CONCRETE CHANNEL

Coal-fired power station - Scotland

A channel used to contain and transport sulfuric acid.

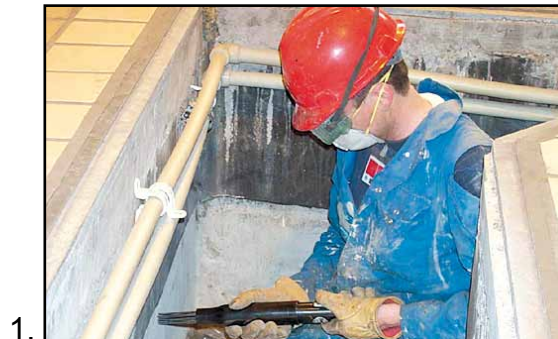
The concrete channel was deteriorated from the acid. A previously applied bituminous screed was failing which caused peaks and troughs in the channel.

1. The surface is being prepared
2. The failed screed can be seen prior to its removal.
3. Belzona® 4181 being applied
4. The channel back in service.

The application was carried out in accordance with Belzona Know-How System Leaflet TCC-15.
