## BELZONA HELPS KEEP THIS POWER PLANT ON-LINE

Power plant in eastern Kansas, U.S.A.

Damaged armature shaft.

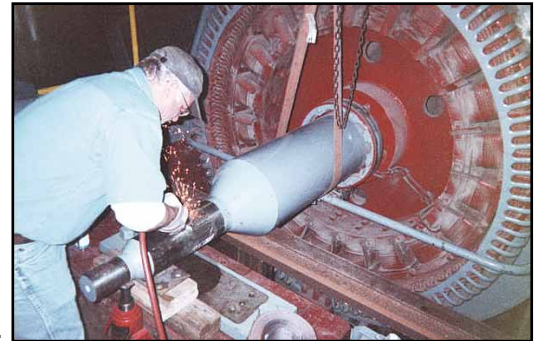
A bearing seizure damaged the armature shaft in fuel generator.

1. Surface preparation.
2. The former is being tightened
3. The former is removed.

Belzonas famous in place split former repair used less than \$50 worth of material and saved this company thousands of dollars in repair costs and downtime.
