## BELZONA REPAIRS A CLASSIFIER AND SAVES THE CUSTOMER THOUSANDS IN REPLACEMENT COSTS

Water Treatment Plant - New Mexico U.S.A.

Solids classifier in the grit removal system.

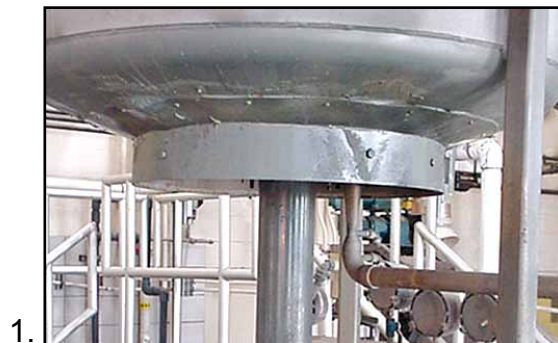
1. An overview of the equipment
2. A close-up of the damage
3. The surface is being prepared
4. The completed repair.

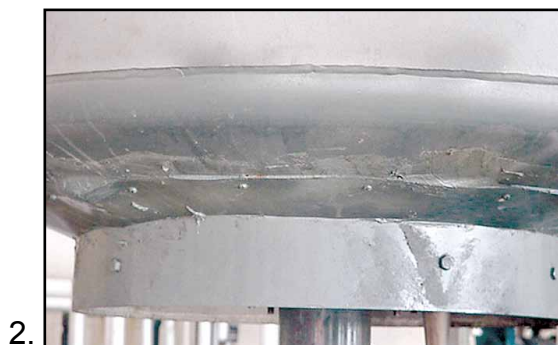
The rubber donut type ring was designed too small allowing the adjacent steel to wear through.
