SUCTION ROLL REFURBISHED WITH BELZONA

Paper mill in Germany

Internal surface of suction roll from paper machine

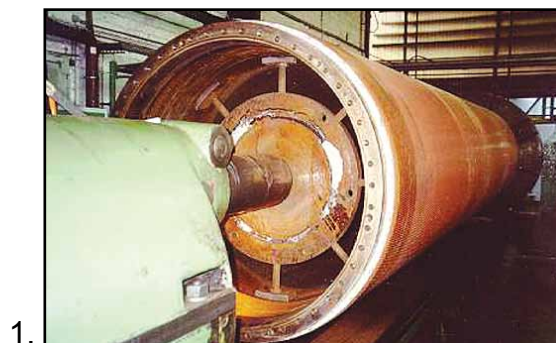
Suction box became loose and scored the suction roll surface.

1. The roll mounted in lathe.
2. Belzona® 1111 applied and some of the re-drilled holes.
3. Final work being done on the rebuilt surface.
4. The completed application.

The application was carried out in accordance with Belzona Know-How System Leaflet PDP-3. Worn area rebuilt with Belzona® 1111, machined to correct diameter, then holes re-drilled through suction roll.
