## BELZONA ALL THAT ITS CRACKED UP TO BE

Sugar beet mill - Minnesota, U.S.A.

Raw sugar storage area.

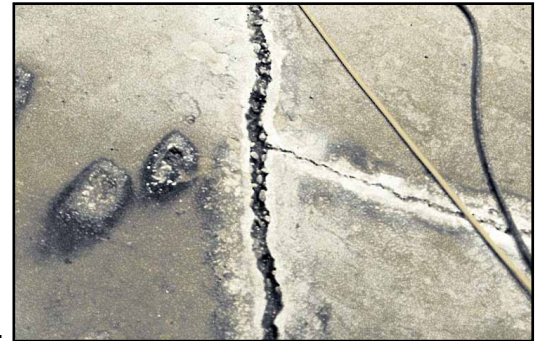
Raw sugar and ambient moisture create an erosive environment over the concrete surface. Over time, the floor's surface spalls and creates safety hazards.

1. View of damaged floor.
2. Cracks are being V-cut and terminated.
3. Spalled area and cracks have been repaired with Belzona® 4111.
