BELZONA REPAIRS LARGE VACUUM PUMP ROTOR

Nash vacuum pump rotor.

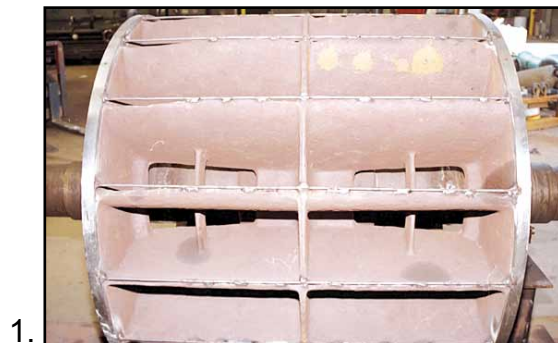
Contamination of the water seal with chemicals and pulp accelerating the erosion - corrosion of the rotor leading to a loss in pump efficiency.

1. The degraded rotor with metal framework welded on
2. The rotor rebuilt to original dimensions with Belzona® 1111
3. The final touches being put to the Belzona® 1341 coating
