## BELZONA REPAIRS KAPLAN TURBINE BLADES IN FRANCE

Kaplan turbine hydroelectric power station on the Moselle River in France.

Erosion-corrosion of the blades leading to large loss in efficiency. In particular, cavitation had caused deep erosion in localized areas.

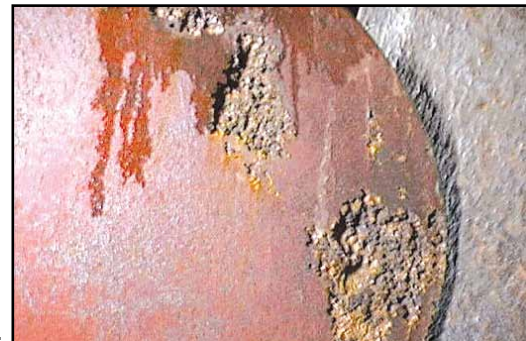
1. Cavitation-erosion damage present on the turbine blades.
2. The blade edges were particularly badly eroded
3. Blade profiles being restored with Belzona® 1111, using plastic strips to obtain edge detail.
4. Completed application. Note the smooth surface obtained with Belzona® 1341.
