## BELZONA RETURNS THIS 20-YEAR-OLD PUMP TO LIKE NEW CONDITION

Electrical utility plant in San Antonio, Texas U.S.A.

The pump had been in service for 20 years and was inspected during a planned outage.

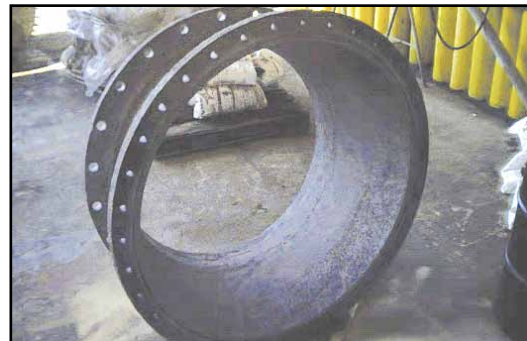
The pump was heavily scaled and had significant corrosion.

1. The pump diffuser connecting piece prior to the application
2. Blasted with Belzona® 1111 applied
3. The pump piece has been coated with Belzona® 1341

The pump was grit blasted and cleaned. Belzona® 1341 was applied to the pump volute, impeller and the inside surfaces of the flow diffuser. Belzona® 5811 was applied to the outside of the volute, the diffuser and the connecting pieces after which Belzona® 1111 was used to rebuild the worn areas on the diffuser and connecting pieces.
