## BELZONA REVIVES 'MOTH-BALLED' POWER PLANT

Power plant in southern California, U.S.A.

A corroded 70-year-old cast iron water box.

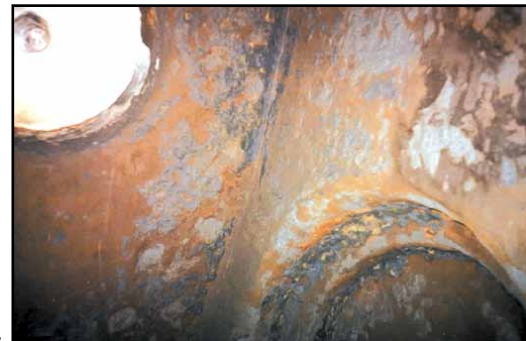
The power plant was sold under California's power industry deregulation and was scheduled to be dismantled. The current energy crisis caused it to be called back on line, however, the water box for two of the units was severely corroded on the inside.

1. View of severe corrosion on the interior.
2. Rebuilding with nearly 1/8 of Belzona® 1121 over the entire surface of about 2,500 square feet.
3. Coating with Belzona® 5811.
4. Sealing edges of box to tube sheet with Belzona® 2211.
