BELZONA PROTECTS INTERNAL BASE OF SEPARATOR

Oil Refinery-Australia

May 2004

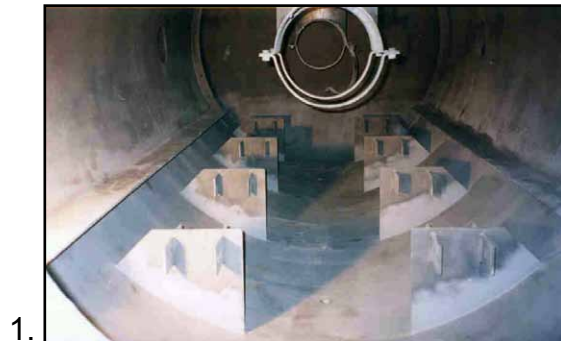
1. Base of vessel grit blasted
2. Stripe coating of welds carried out
3. Completed application

Application was carried out in accordance with Belzona Know-How System Leaflet TCC-5. After thorough cleaning, the vessel was grit blasted and coated with the Belzona® 1591 taking care to initially stripe coat around the attachment bracket welds.
