STANDING WATER - NOT A PROBLEM WITH BELZONA

Air Force Base, Texas - USA

Stainless steel gutters

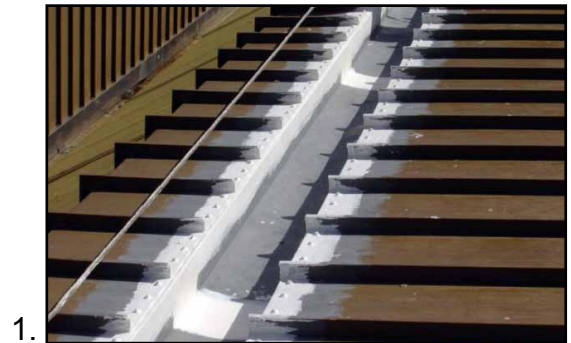
1. Gutters conditioned with Belzona® 3921 and seams coated with Belzona® 3111.
2. Seams coated with Belzona® 3111.
3. First coat of Belzona® 3111.
4. Second coat of Belzona® 3111.
