BELZONA FLEXIBLE MEMBRANE KEEPS TURBINE ROOM AND CONTROL ROOM DRY

Power Cooperative, Texas, U.S.A.

September 2004

Turbine and control rooms.

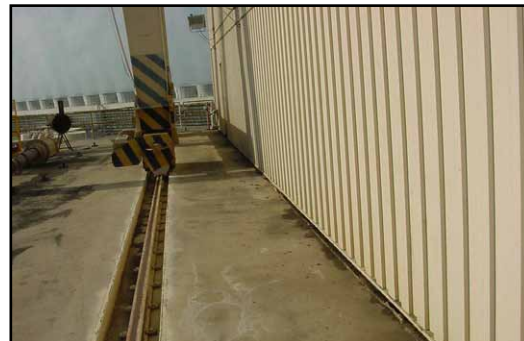
1. Overview of control room wall area and crane track
2. Cleaning out old sealant and failed imitator products
3. Belzona® 3921 (GSC Surface Conditioner) applied
4. Completed repair
