BELZONA REPAIRS/PROTECTS LP STEAM DIAPHRAGM

Power Plant - North Carolina, USA

Low Pressure Steam Turbine Diaphragm

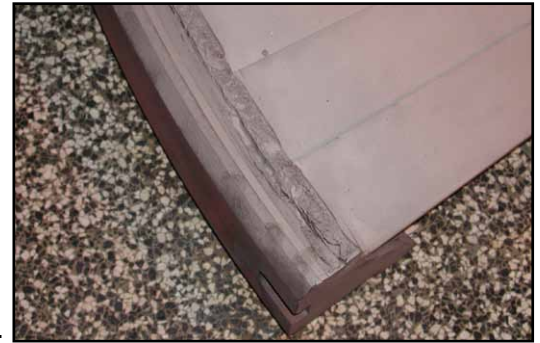
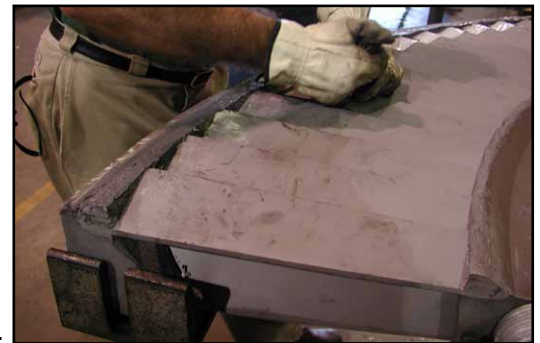
Erosion

1. & 2. Erosion damage is evident
3. Belzona® 1111 (Super Metal) in place
4. Completed application

Sheet metal shields were produced to go over the diaphragms. Welding was considered, but time and costs associated with that were prohibitive. They were able to avoid the excessive cost of welding and its extended downtime. The Belzona approach kept the equipment out of service only one week, thereby keeping the power plant on schedule during their planned outage.
