BELZONA® 2111 (D&A HI BUILD ELASTOMER) SAVES UTILITY

Power Authority, San Antonio, Texas USA

Rubber lined lime slurry tank

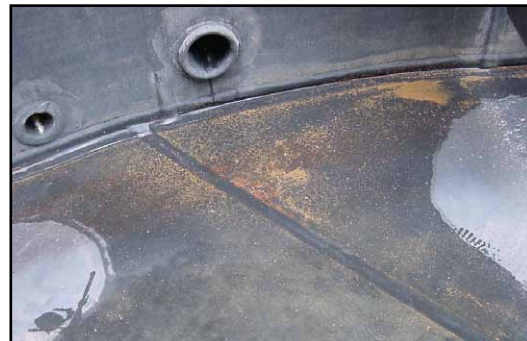
Inspection revealed severe corrosion in spots on floor. Customer needed fast, cost effective repair.

1. Lime slurry tank showing corrosion in rubber liner
2. Another view of corrosion
3. Close up view of corrosion
4. Belzona® 2111 patch complete
