BELZONA SEALS COOLING TOWER AT GOVERNMENT BUILDING

Municipal Building - Ontario, Canada

Cooling Tower

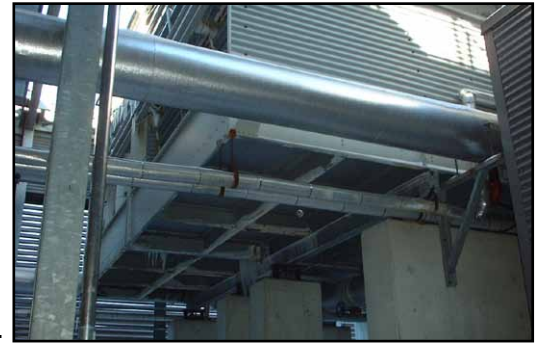
Corrosion and leaks particularly at joints.

1. Exterior image of cooling tower
2. Interior image of the problematic cooling tower
3. Belzona 5811 applied
4. Another shot of the cooling tower, ready for service
