BELZONA PERFORMS A CLASSIC REPAIR

Engine casing on vintage car

A small crack had developed in the 2.8 litre engine casing of this 1951 David Brown Lagonda.

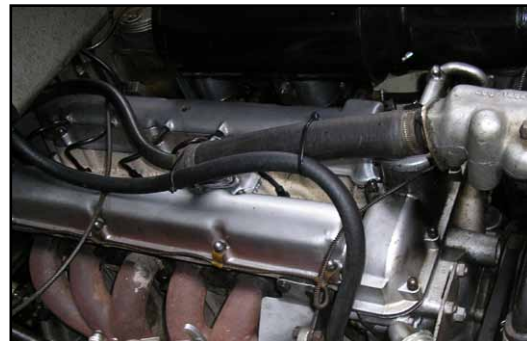
1. The engine block
2. The exterior of this fully restored classic car
3. The cars interior
4. The rear view of the car

Belzona® 1111 (Super Metal)

Belzona® 9341 (Reinforcement Tape)

Application was carried out in accordance with Belzona Know-How System Leaflet ENC-1.
