BELZONA REBUILDS SHAFT ON BLANCHING MACHINE

Frozen Food Manufacturer UK

February 2005

Bearing seat area of blanching machine shaft.

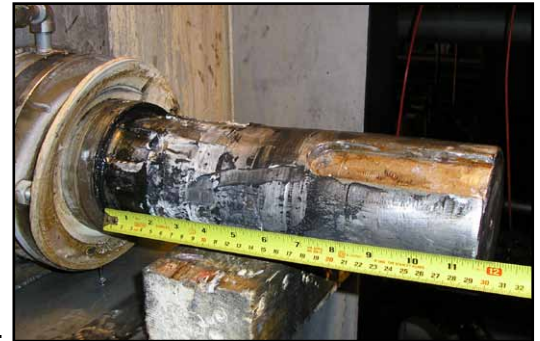
Shaft was worn in the bearing area. This increased pressure on the bearings resulting in a very short service life.

1. View of worn bearing seat area on shaft.
2. View of former. A stepped former was required to allow it to clamp and locate onto undamaged areas of the shaft.
3. Former after clamping in position.
4. Completed shaft rebuild using Belzona® 1111. Note the step has been rebuilt as well.
