KNOW-HOW AND BELZONA® 4111 MAKE CRITICAL REPAIR

Power Plant - Texas U.S.A.

Cooling tower

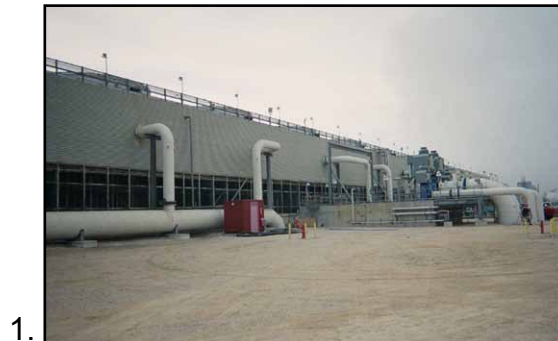
1. Cooling tower at power plant
2. Acid damaged concrete support
3. Belzona® 4111 applied using formers
4. Finished project

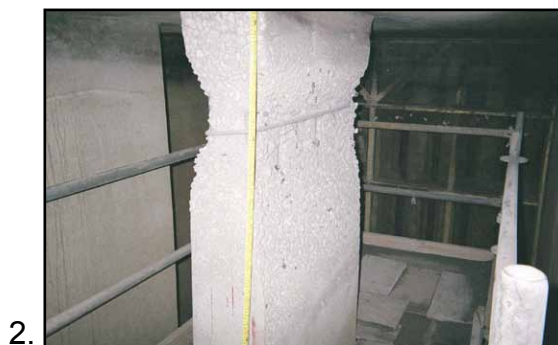
Lack of sufficient mixing of acid used for pH control in cooling tower water caused concrete deterioration on critical support members of cooling tower.

A short outage was planned to make other repairs in the cooling tower when damage was discovered. Client needed a quick solution. Belzona Know-How and its quick-curing Belzona® 4111 allowed this repair to be made in the short shut down period allowed. Acid feed has since been moved to prevent future damage.
