## BELZONA REBUILDS & PROTECTS PUMP IMPELLER

Water Treatment Plant - UK

Impeller from effluent sewage pump.

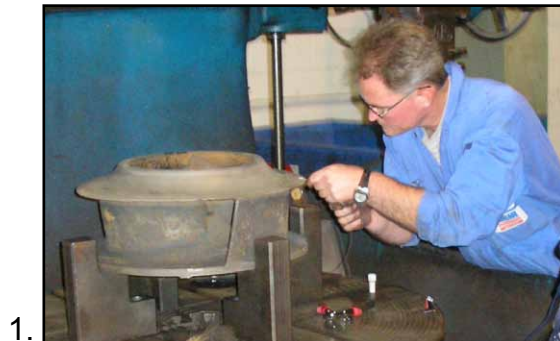
Impeller had moved on its shaft causing it to run against the casing. This resulted in severe abrasive wear and mechanical damage.

1. Impeller on vertical borer prior to cleaning and refurbishment
2. View of wear and mechanical damage. Wire framework was used to reinforce repair
3. Application of Belzona® 1111 underway
4. Completed impeller after application of final coats of Belzona® 1321
