A DURABLE BELZONA COATING FOR CONVEYOR

Chipboard manufacturer - UK

Overhead conveyor

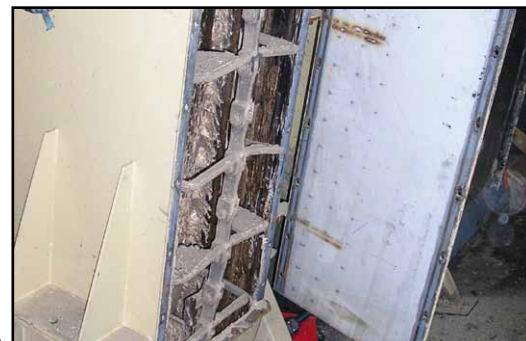
Conveyor suffering build up of product causing flights to drive up into conveyor ceiling. Customer sought to reduce the excessive maintenance down time through the use of Belzona.

1. Conveyor with product build-up clear to see
2. Plate prepared for application of product
3. Product applied to conveyor bottom
4. Conveyor bottom removed to prove performance of Belzona® 1341
