BELZONA: SWEET SUCCESS FOR CHOCOLATE MANUFACTURER

Granite lining (35-mm thick) on a chocolate mixing vessel.

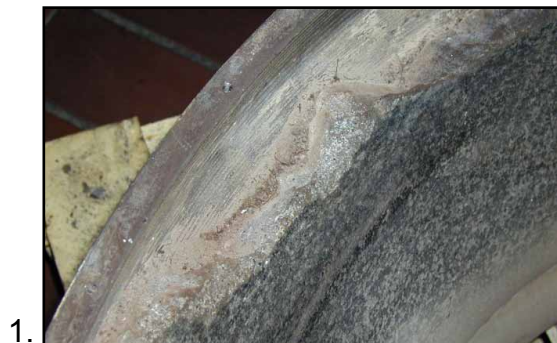
Damaged lining caused by impact through years of service.

1. Close-up of damaged lining
2. Mechanically prepared surface ready for Belzona
3. Completed application
4. Close-up of repaired lining detail
