BELZONA RINGS A TUNE

161-foot bell tower

Roof leaks

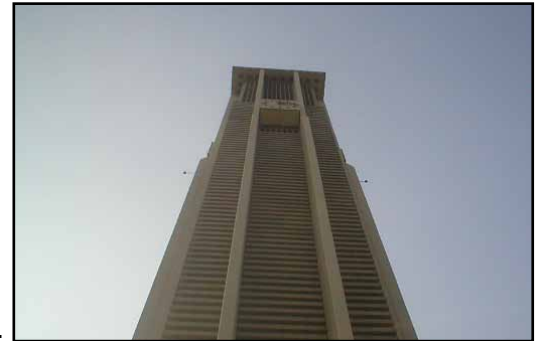
1. The bell tower
2. Leaks were allowing water to ingress the bells bellow
3. Problems clearly evident
4. Completed roof repair
