KEEPING THE PILOTS AFLOAT WITH BELZONA

Leaking fuel oil tank on board a harbour pilot transfer vessel.

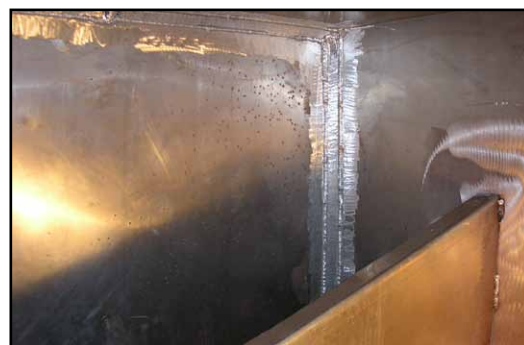
The folded and welded seams of the Aluminium tank had become porous, allowing diesel fuel to leak out.

1. The pilot vessel docked.
2. Preparation and detail of weld seam.
3. The Belzona being applied. The restricted working area is evident.
4. Detail of the finished repair.

Belzona was chosen as a means of providing an effective, long lasting repair. Alternatives would have been to try to weld the damaged areas but as it was the weld seams that were leaking and there was very tight access this was deemed impractical. There was also the contamination and presence of diesel to contend with which further ruled out the use of any hot work. The repair was carried out over the course of two days to allow for full curing of the material before pressure testing and then returning the vessel to service.
