BELZONA REDUCES DOWNTIME FOR CONCRETE BRIDGE EXPANSION JOINT REPAIRS

Department of Transportation - Texas USA

Steel armored expansion joint on a busy interstate/highway bridge.

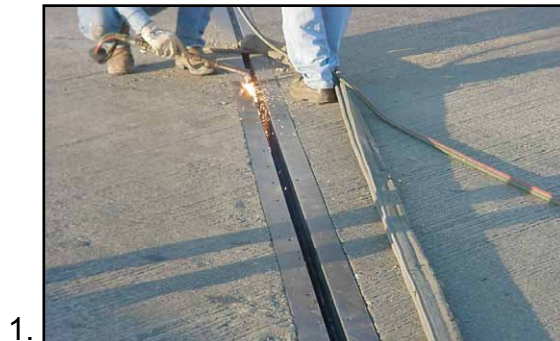
1. Steel armor being cut off.
2. Concrete edges blasted. Old rubber seal will be used as backer rod for Belzona® 4521.
3. Belzona® 4111 being troweled and packed.
4. Completed repair.
