## BELZONA ROLLER REPAIR

Cement manufacturer in Egypt

The roller in a vertical mill at a large cement factory.

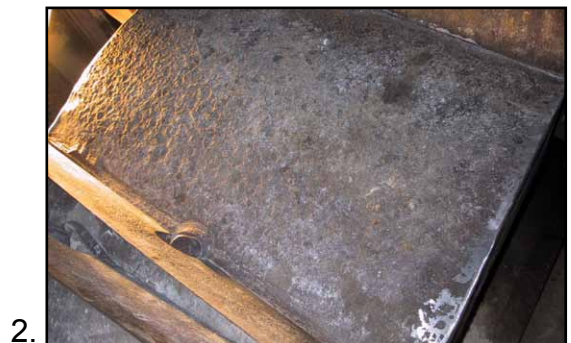
Excessive wear under the steel tile of the roller due to failure of steel tile during operation.

### PICTURES
