BELZONA SAVES SIGNIFICANT DOWNTIME FOR CEMENT PLANT

Cement plant - United Arab Emirates

Crusher shaft

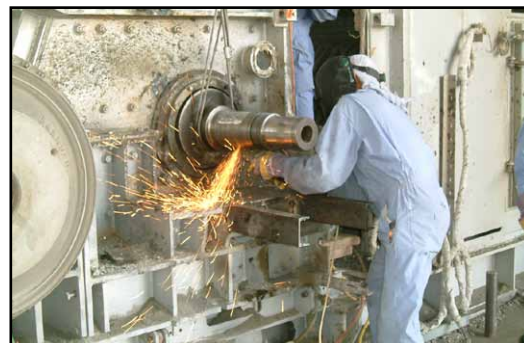
1. Surface preparation in progress
2. Prepared surface, ready for Belzona to be applied
3. Completed application
4. General view of crusher shaft in operation after the application

Application was carried out in accordance with Belzona Know-How System Leaflet MPT-1 and MPT-2.
