BELZONA FLOATING ROOF REPAIR

Oil refinery, Egypt

Floating roof - crude oil tank

Crude oil leakage through welding seams in the tanks floating roof.

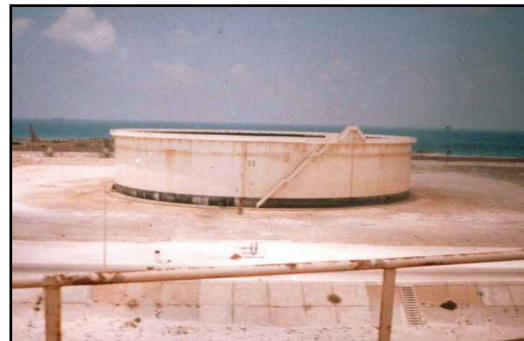
1. General view of the crude oil tank
2. The contaminated area of the floating roof
3. Cleaning the surface
4. Leakage stopped (shown) and in other locations
