## BELZONA REPAIRS & PROTECTS FILTERS

Five star hotel - Egypt

Media filters for the hotels swimming pool.

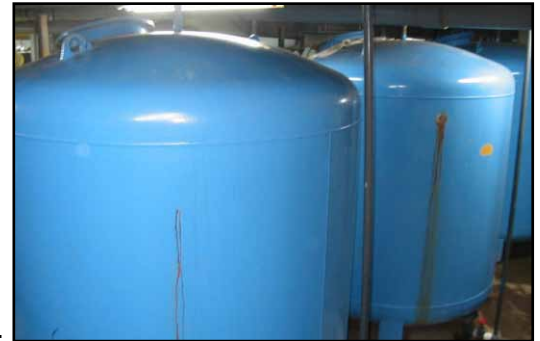
1. General view of the media filters
2. Holes caused by corrosion
3. Old coating failed
4. Coating was completed after all holes were plugged

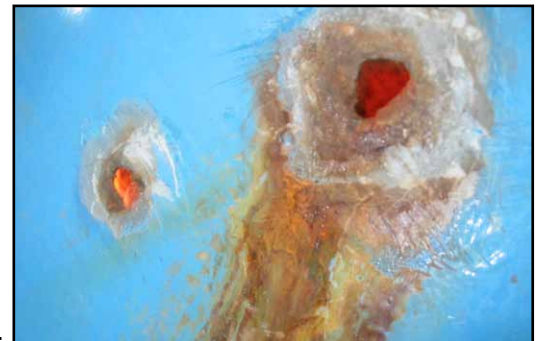
2.

Severe corrosion of the filters after the failure of its internal coating. The corrosion also caused many holes in the bodies of the filters which were leaking during operation.

Previous coating had failed causing many holes and leaks. Belzona Marine Metal sealed all the holes, while Belzona® 1341 was used as a protective coating to prevent future corrosion. Belzona® 1341 also was chosen due to the fact that it is NSF Approved.
