BELZONA REPAIRS RUBBER PONTTOON

Amusement park - Egypt

Rubber pontoon in a water ride.

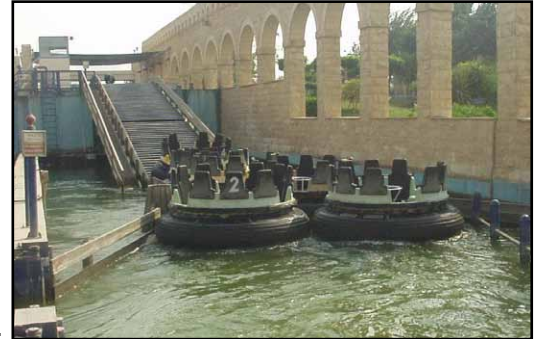
1. General view of the rubber pontoons
2. The worn out pontoons
3. Surface preparation
4. Applying Belzona® 2121 to the damaged areas

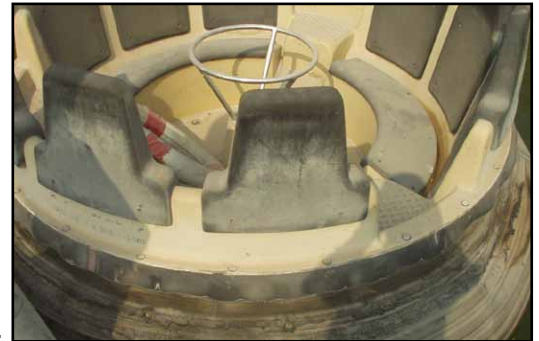
2.

The rubber pontoon was worn out in several areas from the effects of water and impact.

These rubber pontoons are pushed through the lake by strong flow. It was critical and unsafe to use the pontoons in there condition. Belzona 2121 was used to repair the worn out areas and also to protect the pontoon from future damage, saving the cost of new units.
