## VALVE REPAIR AND PROTECTION WITH BELZONA

Power plant, Egypt

Automatic chemicals valve.

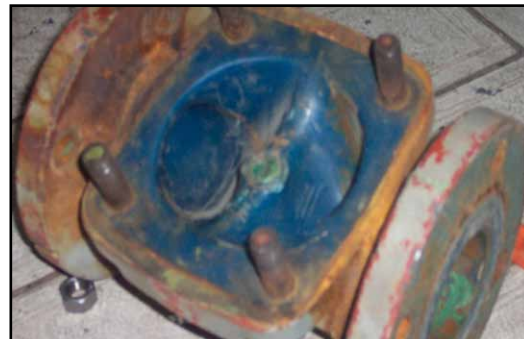
Old polypropylene lining was worn and damaged due to chemical attack.

1. The valve before repair
2. Former made by casting with Belzona® 5811
3. Belzona® 1311 applied to the valve
4. Two valves were repaired and protected
