BELZONA REPAIRS LOOSE WEAR RING

Power plant - Egypt

Wear ring in main cooling water pump

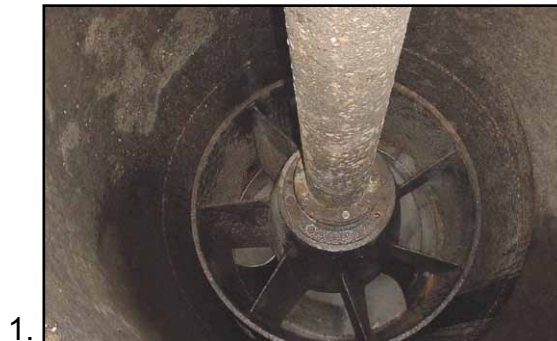
1. General view of the pump
2. Corrosion caused wear at the ring
3. Application of the first layer of Belzona® 1321
4. Removing excess material after injecting the second layer of Belzona® 1321

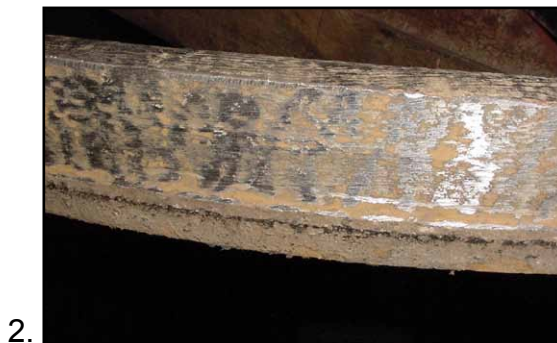
Ring had become loose in its housing.
