BELZONA PROPELLER REPAIR - TUGBOAT

Voith Schneider® Propellers on a large tugboat.

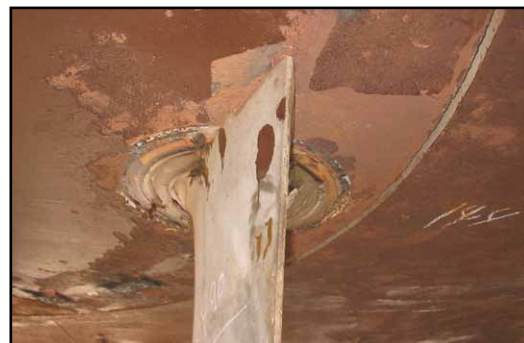
The propellers were severely corroded-eroded. A previous coating had failed; holes and pitting were found in many locations.

Welded joints were the most severely damaged areas, but additional welding to repair the problem would cause heat distortion and unacceptable delay in drydock. Belzona was the best solution to repair and protect this equipment.

1. General view of the tugboat
2. Erosion-corrosion evident
3. Surface after blasting
4. Application of Belzona to protect the propellers
