BELZONA REPAIRS RUBBER GEAR CASTING

Cooking vessel manufacturer, Egypt

Rubber gear

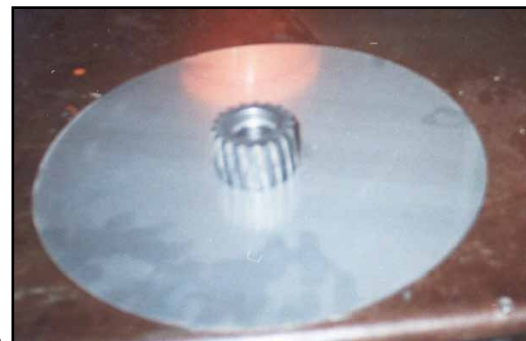
A replacement was needed; gear needed to be cast due to costs and downtime associated with importing a replacement.

1. The rubber section which needed to be cast
2. Preparing the mold
3. Rubber mold completed
4. The cast gear and the mould ready to cast another new gear

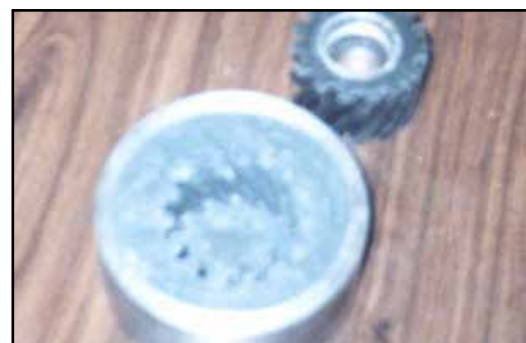
4.

The rubber gear was produced at only 25% of the cost of an imported gear. The mould was also produced using Belzona. The new gear was ready for use in only one day saving significant time over importation.
