BELZONA REPAIRS LARGE HYDRAULIC RAM

Eight meter hydraulic ram of a transport winch

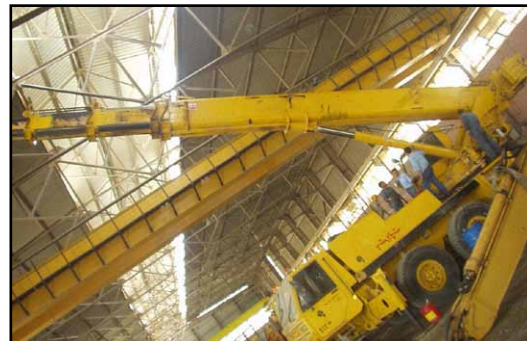
1. General view of the hydraulic ram
2. Scores on the ram
3. The ram after repair
4. Finishing the surface then cleaning it

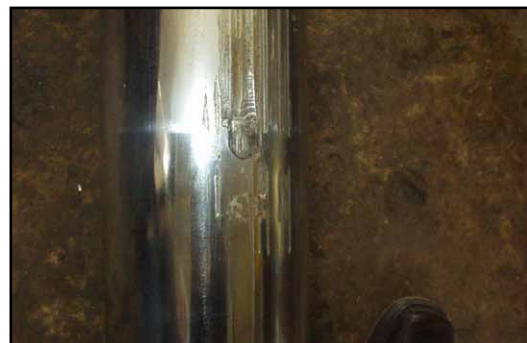
2.

Deep and wide scores in many areas of the ram.

There were scores in many areas of the ram causing many leakages and fluid losses. Belzona saved the replacement costs of the ram, returning it successfully to service.
