BELZONA REPAIRS AND PROTECTS CORRODED SHELL

Petrochemical facility, Egypt

Heat exchanger shell

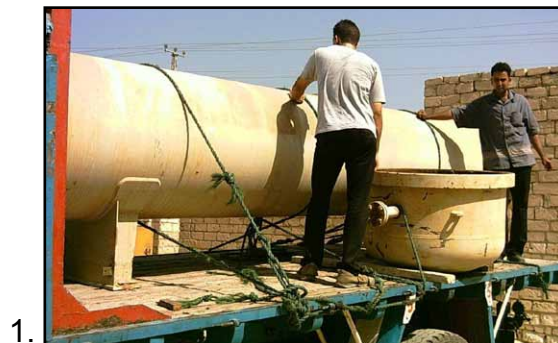
1. General view of the shell and cover.
2. The corroded surface inside the shell.
3. Forming the applied Belzona® Marine Metal.
4. Belzona® Marine Metal rebuild successfully completed. Belzona® 1321 applied to provide overall corrosion protection.

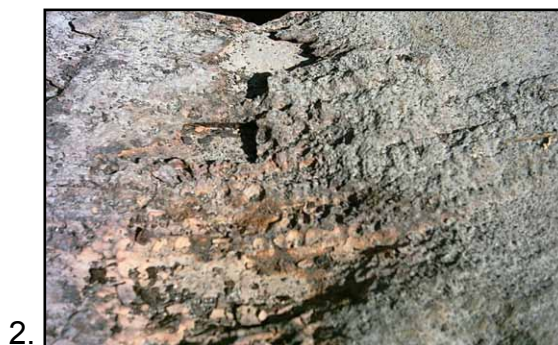
Shell and dished end were highly corroded due to chemical attack that resulted in critical wall thickness reduction in the shell.

Application was carried out in accordance with Belzona Know-How System Leaflets HEX-2 and HEX-3. Belzona® Marine Metal was used to restore the original dimensions then Belzona® 1321 was used to protect the restored area from any further corrosion.
