BELZONA EMERGENCY LEAK SEALING

Oil refinery, Egypt

Tube sheet in nitrogen production unit working at 8 bar

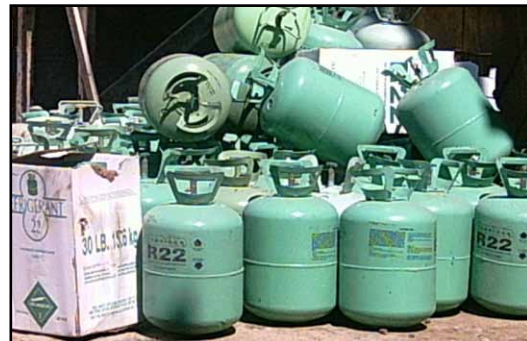
1. General view of the consumed Freon containers used to replenish leaks.
2. The tube sheet suffering from Freon leakage
3. Surface preparation by grit blasting
4. Belzona® 1321 applied to stop the leakage

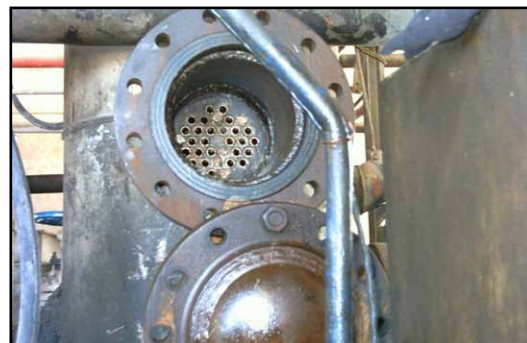
2.

Bi-metallic corrosion between the tubes and the tube sheet had caused Freon leakage.
