BELZONA REPAIRS DAMAGED GEAR BOX

Petrochemical facility, Egypt

Service vehicle gear box

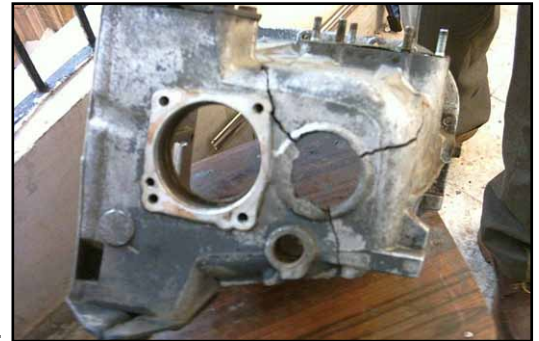
The gear box was badly cracked and fractured.

1. Fractured gear box
2. Stabilizing the long cracks of the gear box
3. Using metal strips to reinforce the crack
4. Repair completed after applying Belzona® 1111 to the cracked surface
