PIPE REPAIR ON TANK

Chemical Company - Canada

April 2005

Fiberglass outlet pipe on tank developed a new leak. Sulfuric acid in steam.

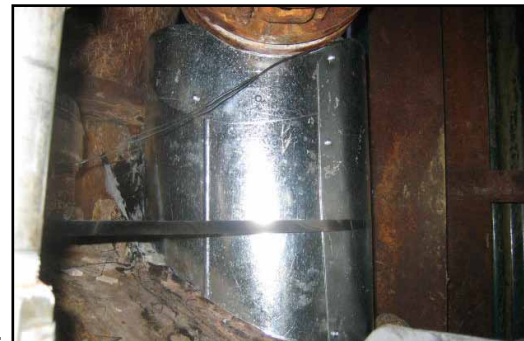
1. Former for pipe was installed
2. Belzona® 1221 put in place to dam the leak through areas
3. Belzona® 5811 was mixed and poured into former
4. Finished job
